## Thermography Report

Town of Shrewsbury  
Parks and Cemetery Department  
Underground Water Pipe Leak at  
Mountain View Cemetery  
Route 140, Boylston Street  
Shrewsbury, MA 01545

Thermography Date: May 14, 2009  
Thermographer: Gerald T. Brady  
Outdoor Temperature: 58 F  
Weather: Cloudy

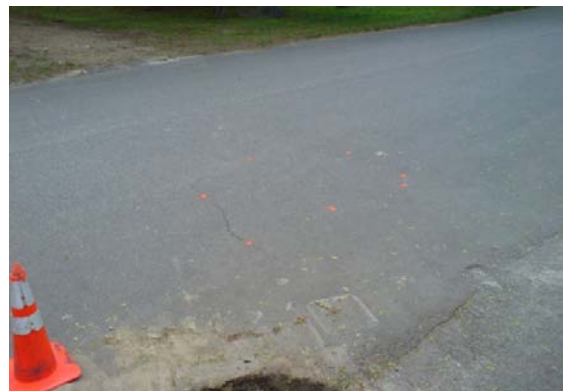
**Picture 2. Captured at: Mountain View Cemetery**

**Comment: Water line leak below surface of road. Road surface temperature is approximately 67 F. Coldest areas from water break are showing surface temperatures of approximately 62 F.**

**Recommendation: Excavate at coldest area on thermograph shown in black.**

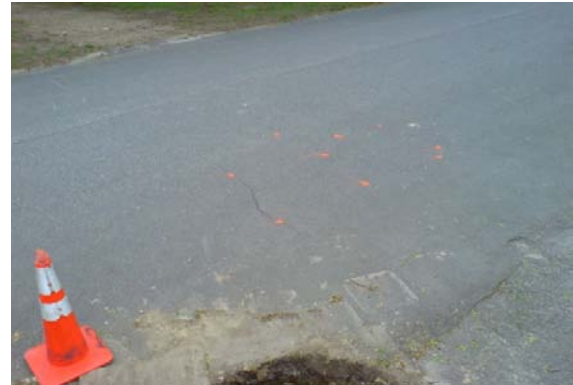
**Picture 3. Captured at: Mountain View Cemetery**

**Comment: Water line leak below surface of road. Road surface temperature is approximately 67 F. Coldest areas from water break are showing surface temperatures of approximately 62 F.**

**Recommendation: Excavate at coldest area on thermograph shown in black.**

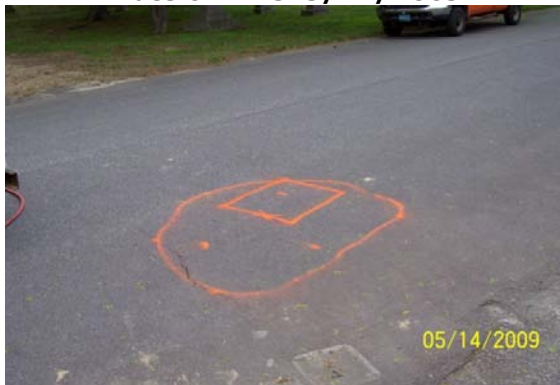
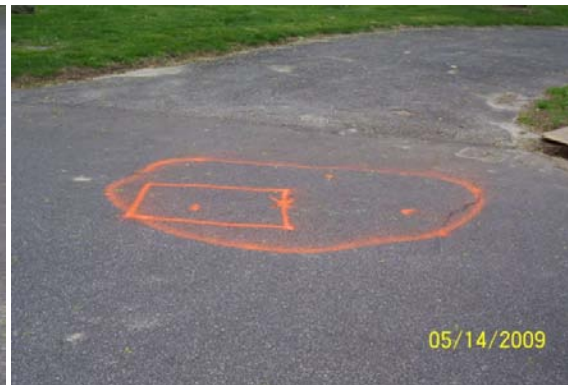
**Picture 4. Captured at: Mountain View Cemetery**

**Comment: Entire area affected by leak is marked in a circle. Boxed out area within circle area has a single spot indicating coldest temperature thus pinpointing exact leak area.**

**Recommendation: Excavate boxed out area only.**

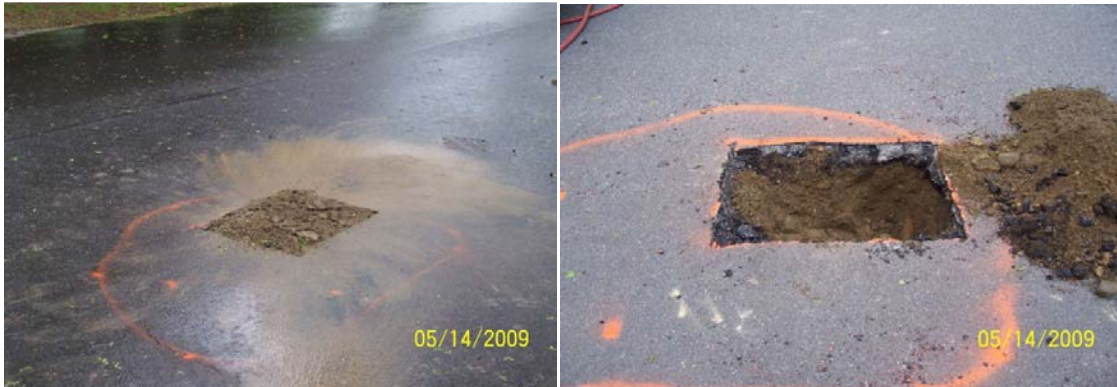
**Picture 5. Captured at: Mountain View Cemetery**  
**Date & Time: 5/14/2009 11:24:44 PM**

**Comment: Boxed out area excavated. Two different views.**

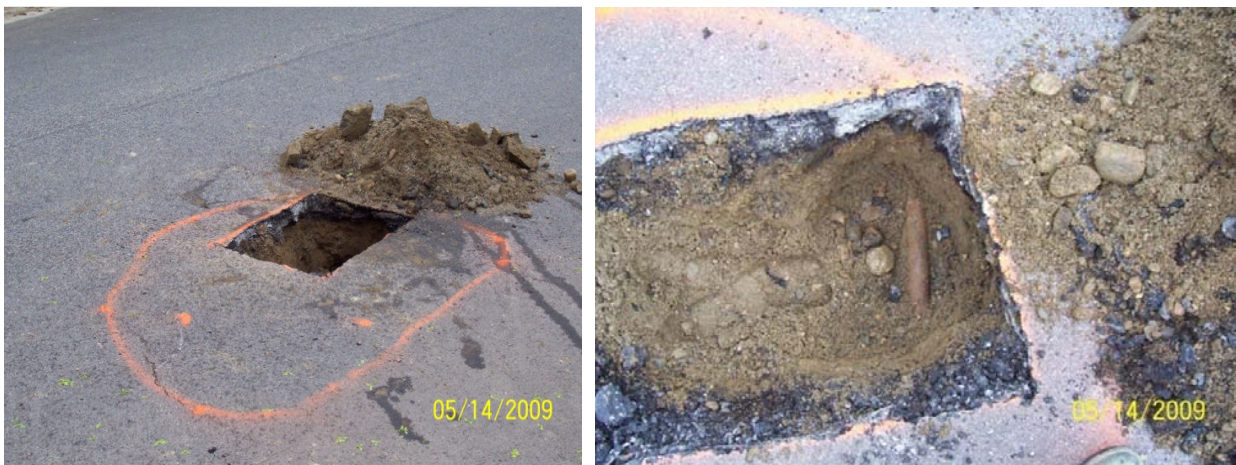
**Picture 6. Captured at: Mountain View Cemetery**  
**Date & Time: 5/14/2009 11:24:44 PM**

**Comment: Boxed out area excavated. Two different views. Right side shows pipe. Depth of pipe 18", including 4 inches of asphalt.**

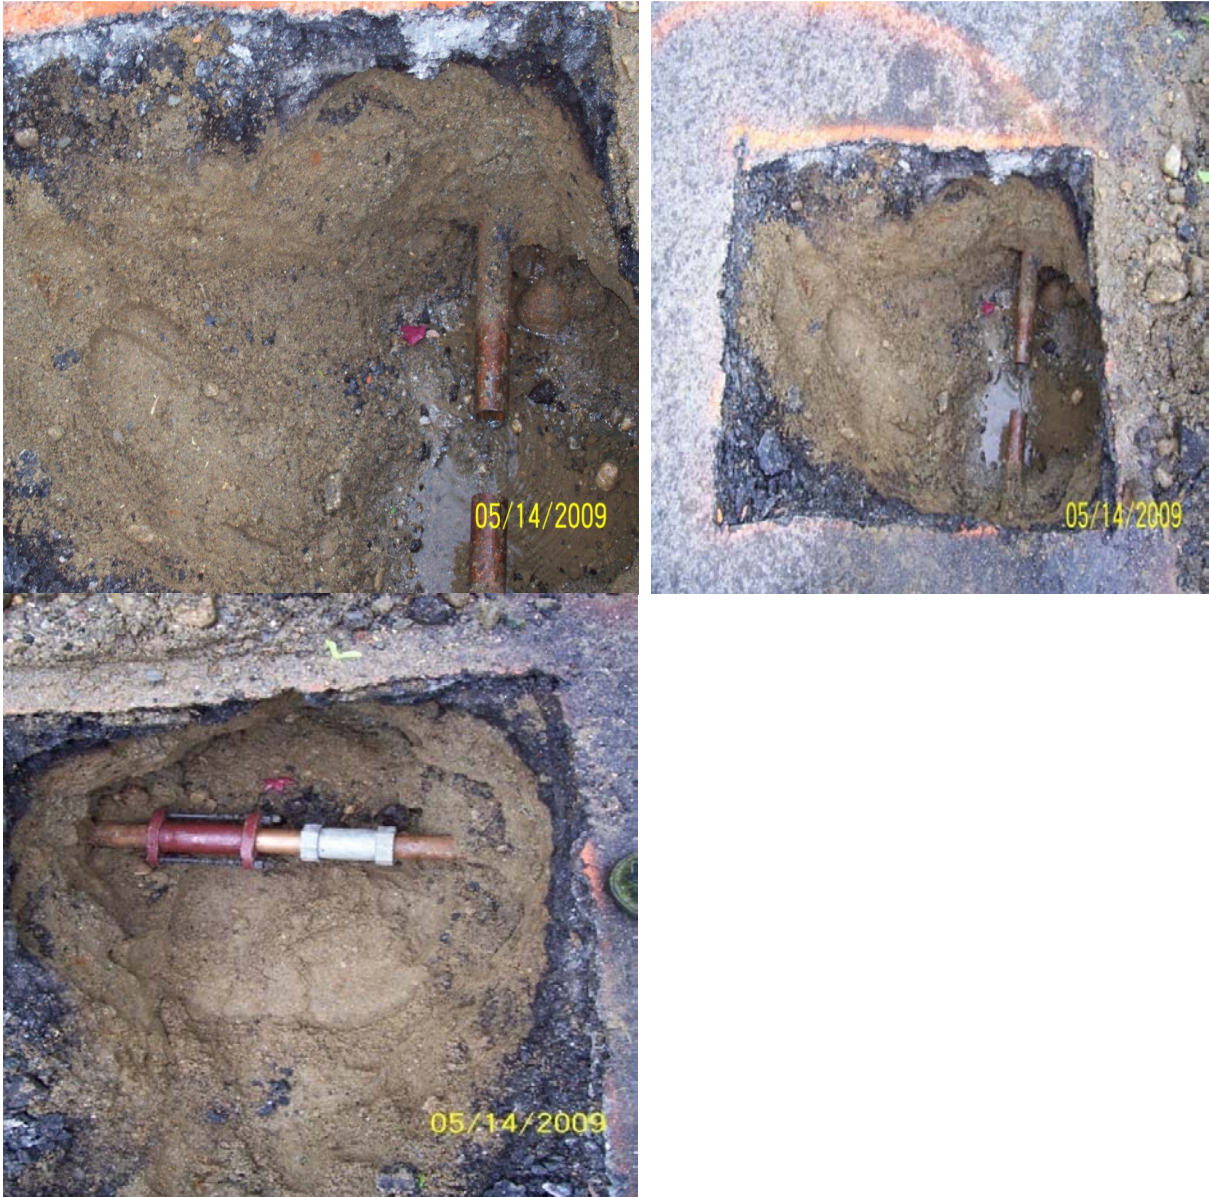
**Picture 7. Captured at: Mountain View Cemetery**  
**Date & Time: 5/14/2009 11:24:44 PM**

**Comment: Boxed out area exposed leak at single spot indicating coldest temperature thus pinpointing the exact leak area. Depth of pipe 18", including 4 inches of asphalt.**

**Repair was completed in last photo.**
